Test Report

No.: SZXEC26001413203

Sample Name: Silicone Rubber

Model No.: TN750

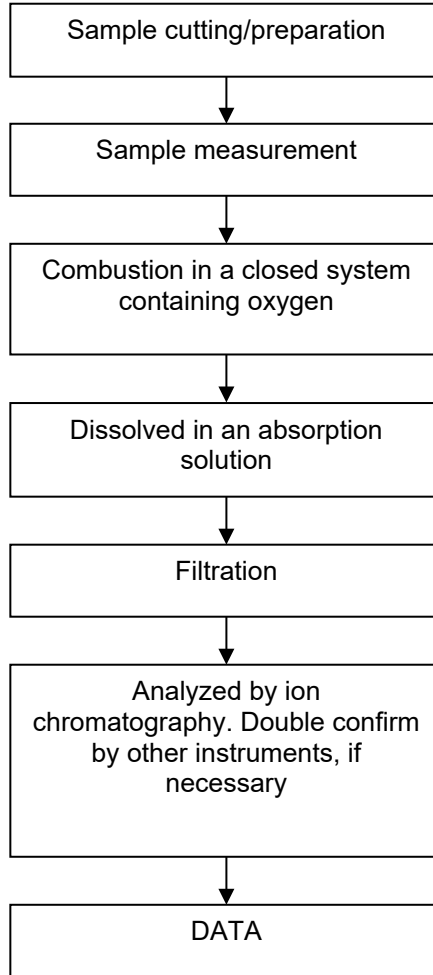
Halogen Testing Flow Chart

Test Method: With reference to EN 14582:2016, analysis was performed by IC.

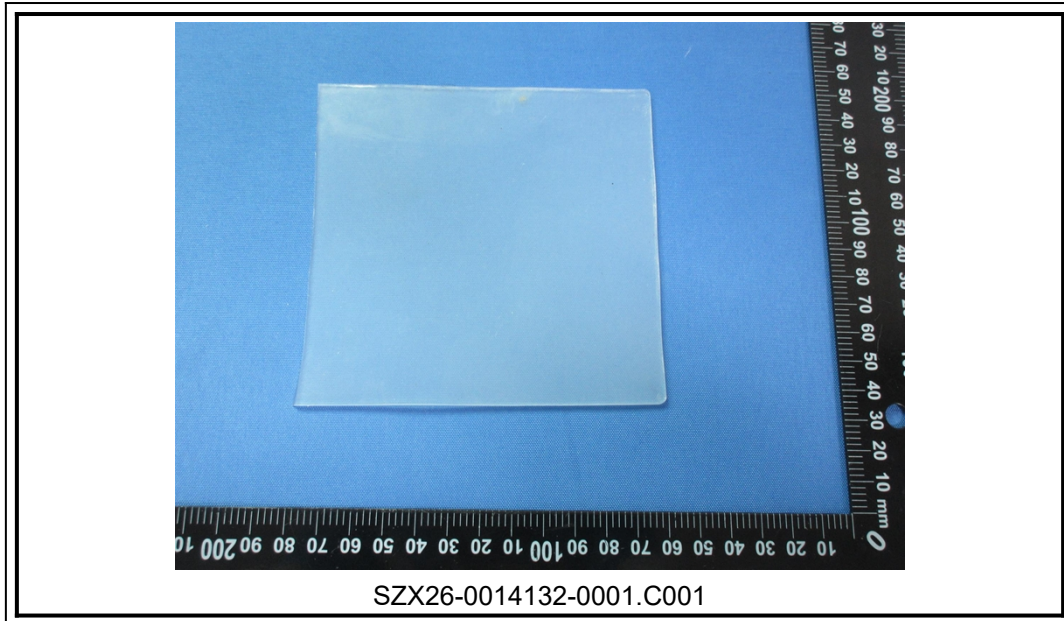
Sample Photo:

SN ID	Sample No.	SGS Sample ID	Description
SN1	A1	SZX26-0014132-0001.C001	Colorless transparent silicone rubber
